DELAWARE RIVER BASIN
MANTUA CREEK, GLOUCESTER COUNTY
NEW JERSEY

STERLING LAKE DAM
NJ 00434

PHASE 1 INSPECTION REPORT
NATIONAL DAM SAFETY PROGRAM

STERLING LAKE DAM (NJ00434)

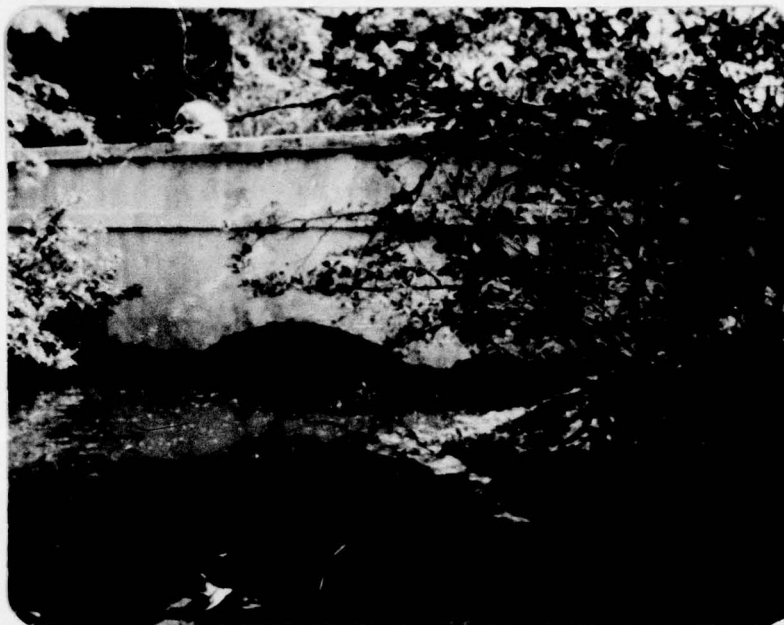
The reinforced concrete arch bridge is in excellent structural condition in view of its age. The wingwalls and parapets display minor cracking and spalled areas but the structurally important zones are in an integral condition. The semi-circular culvert opening has a clear span of 16 feet. The headroom above a reinforced concrete paved invert is about 7 feet. The paved invert which forms the culvert floor is 6" thick and was installed when the spillway was built. The lower portions of the culvert are permanently inundated by the backwater from Wadsworth Lake immediately downstream, leaving a clear headroom of only two feet beneath the intrados crown. This backwater condition from the lower reservoir severely limits the hydraulic capacity of this outlet.

View of Outlet Structure

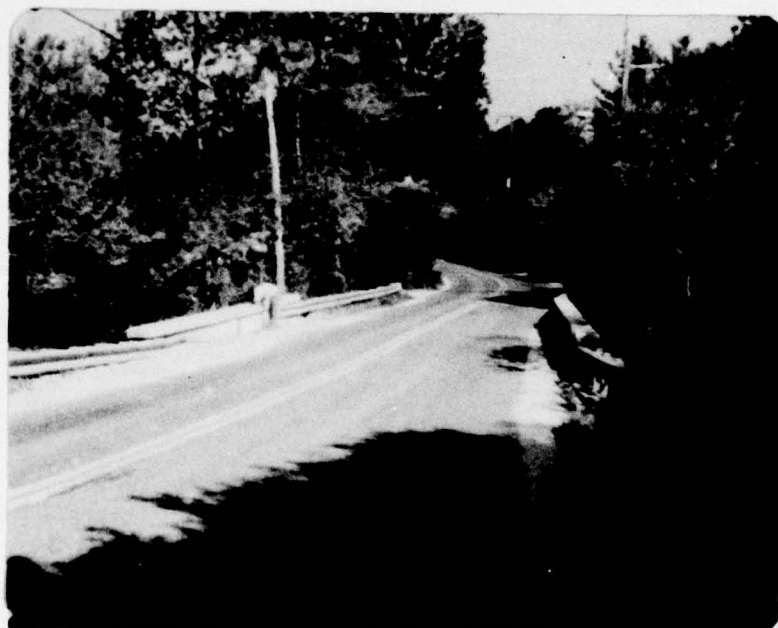
The roadway embankment portions were found to be substantial and in moderately good condition. The lake water level appears to be quite constant during most periods as the banks are well stabilized and show little evidence of sloughing at the waterline. The variable sideslopes are grassed over and have several good-sized trees placed along each side. There is evidence of considerable pavement runoff in certain locations which have cut out erosion channels. The upstream embankment slope is very irregular and it appears the lake has silted up considerably against the upstream face of the dam. There is no evidence of any riprap slope protection.

View of Crest Looking North
